# Safety Advisory No. 2015-05 Presentation

## 54<sup>th</sup> Railroad Safety Advisory Committee Meeting

November 5, 2015  
Washington, DC

Addressing Rail Head Surface Conditions Identified during the Internal Rail Inspection Process

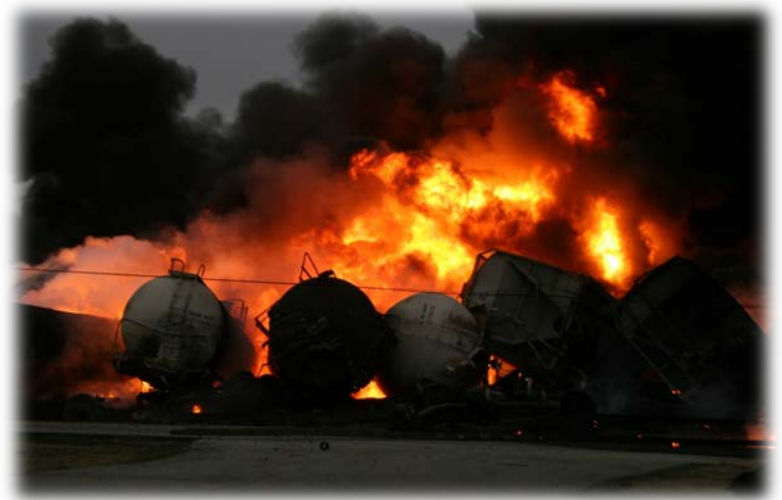
- On February 16, 2015, a derailment occurred in West Virginia.
- Derailment was attributed to a vertical split head (VSH) failure
- Twenty-seven tank cars derailed
- Approximately 378,000 gallons of crude oil ignited
- Oil burned for 4 days resulting in evacuation of residents within a half-mile radius of the accident site.

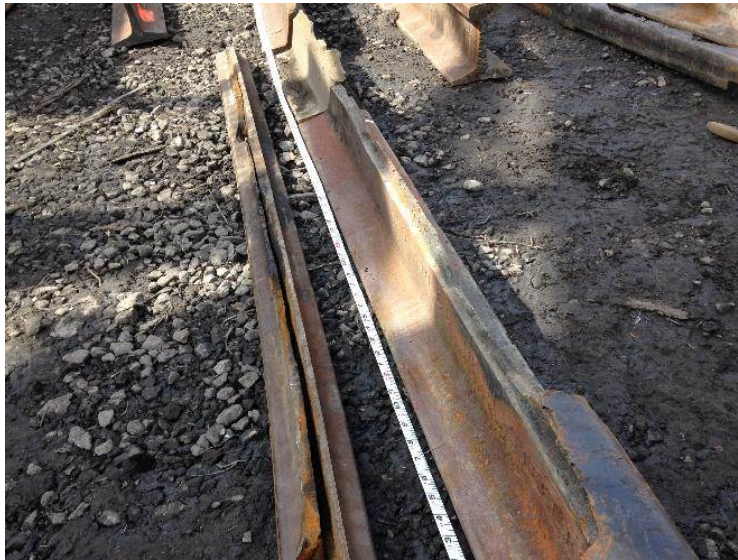
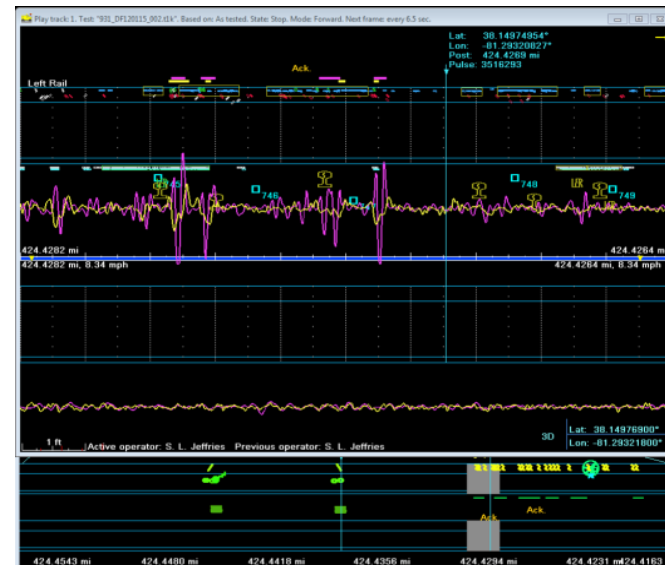
- FRA reviewed the rail test data from the previous December 2014 and January 2015 rail inspections.
- The data indicated a significant rail head surface anomaly or longitudinal rail head defect such as the VSH defect.

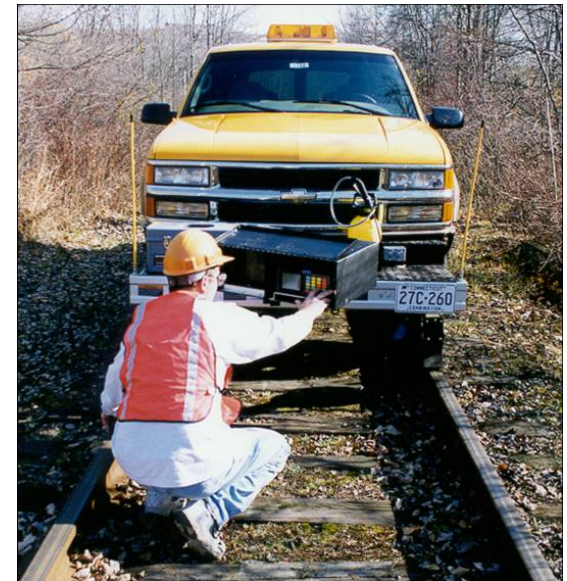
- 1) The equipment responses were caused by a **“dirty”** rail
- 2) The test system **“couldn’t see”** into the rail due to the surface condition
- 3) He **wasn’t trained** on CSX special instructions regarding suspect SSCs
- 4) The operator felt that a **valid search** was conducted despite the presence of the surface condition.

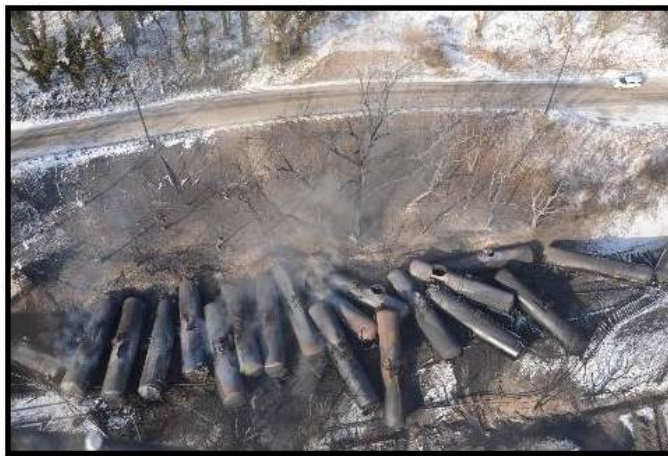
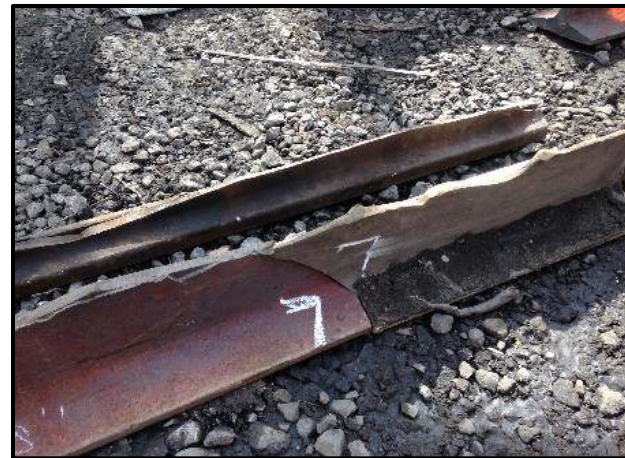
- that the presence of the rail head surface condition was not sufficient to account for the equipment response in its entirety
- that the rail flaw detection equipment operator should have performed a visual ground examination, or hand test, or both, was warranted.
